# Home Inspection Report

**123 Anywhere Street  
Anytown, PA 18888**

**Prepared by:** Jeff Remas ASHI # 243345 on January 02, 2007

**REMAS Inspections, Inc.**

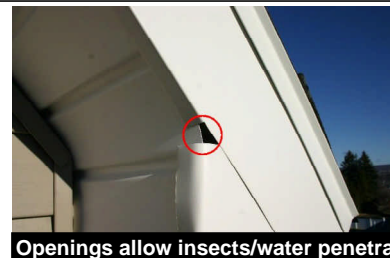
**Repairs needed:** Front area has soffit cut short & not tucked under fascia lip. Openings around aluminum coil stock trim for soffit areas at the dormers. The same area did not have mechanical bends of the aluminum coil stock to assist in holding the soffit in place

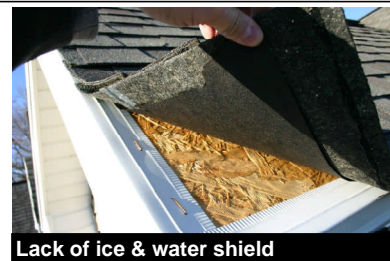
<u>Location:</u>	Main Structure.
<u>Style:</u>	Gable.
<u>Type:</u>	Composition shingles.
<u>Roof Access:</u>	Walked on roof.
<u>Roof Covering Status:</u>	Nails/Fasteners are exposed/protruding from the roof surface. <b>Repairs needed:</b> The roof lacks an ice & water barrier underlayment on the edges in most areas as required by current standards and per the approved plans. The house is susceptible to damage from ice damming.

Lack of ice & water shield

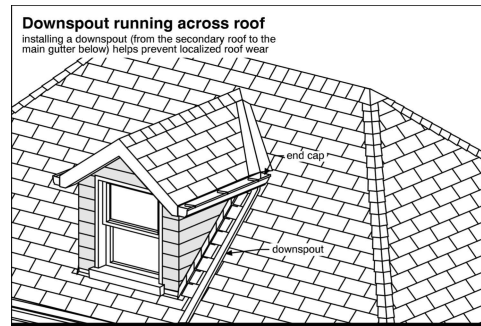
Appears serviceable, **Repairs needed:** No secondary drain(s) on roof. This will develop a wear pattern and reduce life expectancy in the affected area.

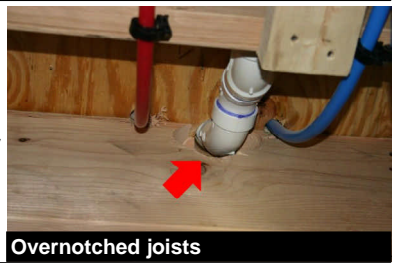
<u>Ventilation:</u>	Appears Serviceable.
<u>Beams:</u>	Appears serviceable.
<u>Floor Joists:</u>	<p>Appear serviceable, <b>Repairs needed:</b> Joist hangers have missing nails and screws that are installed are not approved fasteners and should be replaced with the proper sized nails. Overnotched joists near the stairwell</p>

**Overnotched joists**

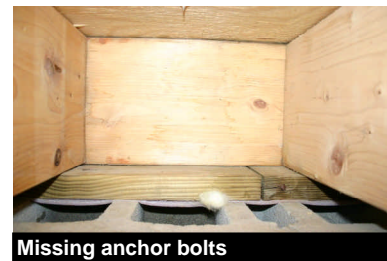
with anchor bolts, **Repairs needed:** The anchoring system is improperly installed with missing anchor bolts within 12" of ends.

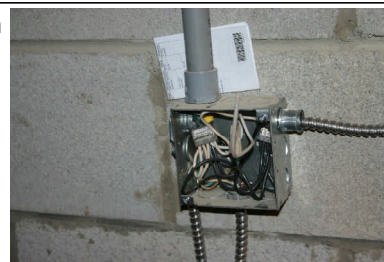
<u>Entrance Cable Type:</u>	Copper.
<u>Branch Wiring:</u>	Copper. Not completed yet. Open junction boxes with missing covers.
